**SPG9000**

**Timing and Reference System**

**Release Notes**

This document supports firmware version 3.1.1

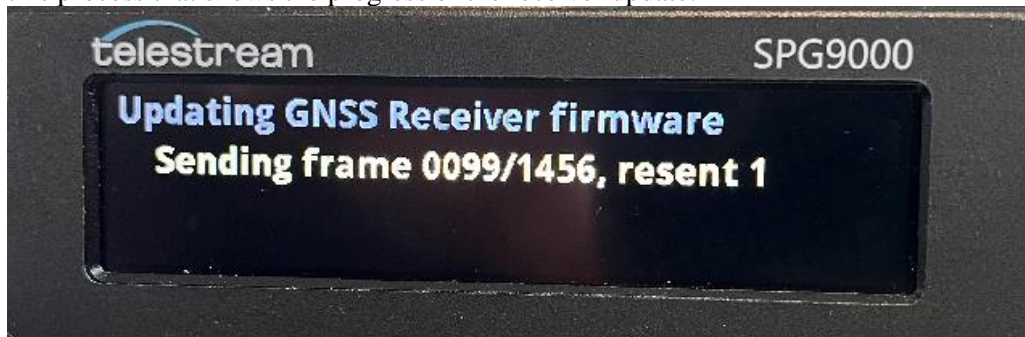
- GNSS** The SPG9000 firmware update now includes an update for the firmware of the internal GNSS receiver. A small number of SPG9000 systems were incorrectly shipped from the factory with version 1.00 of the GNSS firmware, and these systems occasionally unlocked from the GNSS signal. After upgrading to SPG9000 firmware version 3.1.1, the GNSS receiver will be upgraded to its firmware version 1.02.

With the receiver update, the SPG9000 upgrade process will take an extra 7 minutes to complete, for a total upgrade time of 20-30 minutes. You will see a message during this process that shows the progress of the receiver update:

It is not unusual to see a small number of resent frames. The SPG9000 may reboot itself a number of times during its upgrade. After the SPG9000 update has completed and you see the **STATUS** menu from the front panel display, you must cycle the AC power to restart the SPG9000 once again. In some instances, the GNSS receiver update may need to restart the process after the reboot. If it does, please wait until the **STATUS** menu appears again and repeat the power cycle process.
